## ***WHAT'S HAPPENING?***

***April 2006***

### **10 Day Investigation Report**

## Explosion of vacuum truck and tank fire

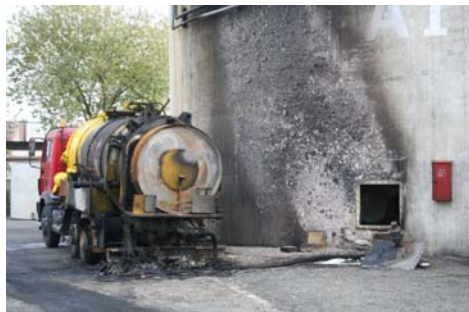
The vacuum truck was destroyed; the tank and its' concrete bund wall were heavily damaged.

- vapours from the tank entered the truck engine air intake;
- the truck engine raced (over-speeding) and immediate attempts to decelerate it from the control panel at the back of the truck were not successful.

1. Gasoline vapours from tank manway reached air intake of vacuum truck engine.
2. Engine of vacuum truck couldn't be stopped.

- The change in operating conditions from "using the vacuum truck near close manway" to "using the vacuum truck near open manway" did not trigger reconsideration of location/adequation of the truck despite shifting wind conditions and known high vapours levels (above LEL detector alarm) at manway.

- The truck was not fitted with an over-speed protection device.

*Destroyed truck and fire damage on concrete bund wall*

The root causes are linked to inadequate risk analysis and prevention (lack of in-depth analysis of previous similar incidents in the Industry, including BP; cleaning procedure), inadequate risk assessment and management (procedure for vacuum truck and permit to work implementation), and inadequate safety devices (diesel-engine over speed protection).

- Review existing procedures of contractor management, as well practices for use of vacuum trucks. (e.g. gas detection frequency)
- Refresh training accordingly.
- Improve lessons learned capture.
- Verify adequacy of diesel engines used near/in hydrocarbon areas.
- Review communication process of Safety bulletins / guidelines.
